HAZARD RANKING SYSTEM (HRS) DOCUMENTATION RECORD COVER SHEET

Name of Site: Donnelsville Contaminated Aquifer

EPA ID No.: OHN000510459

HAZARD RANKING SYSTEM (HRS) DOCUMENTATION RECORD

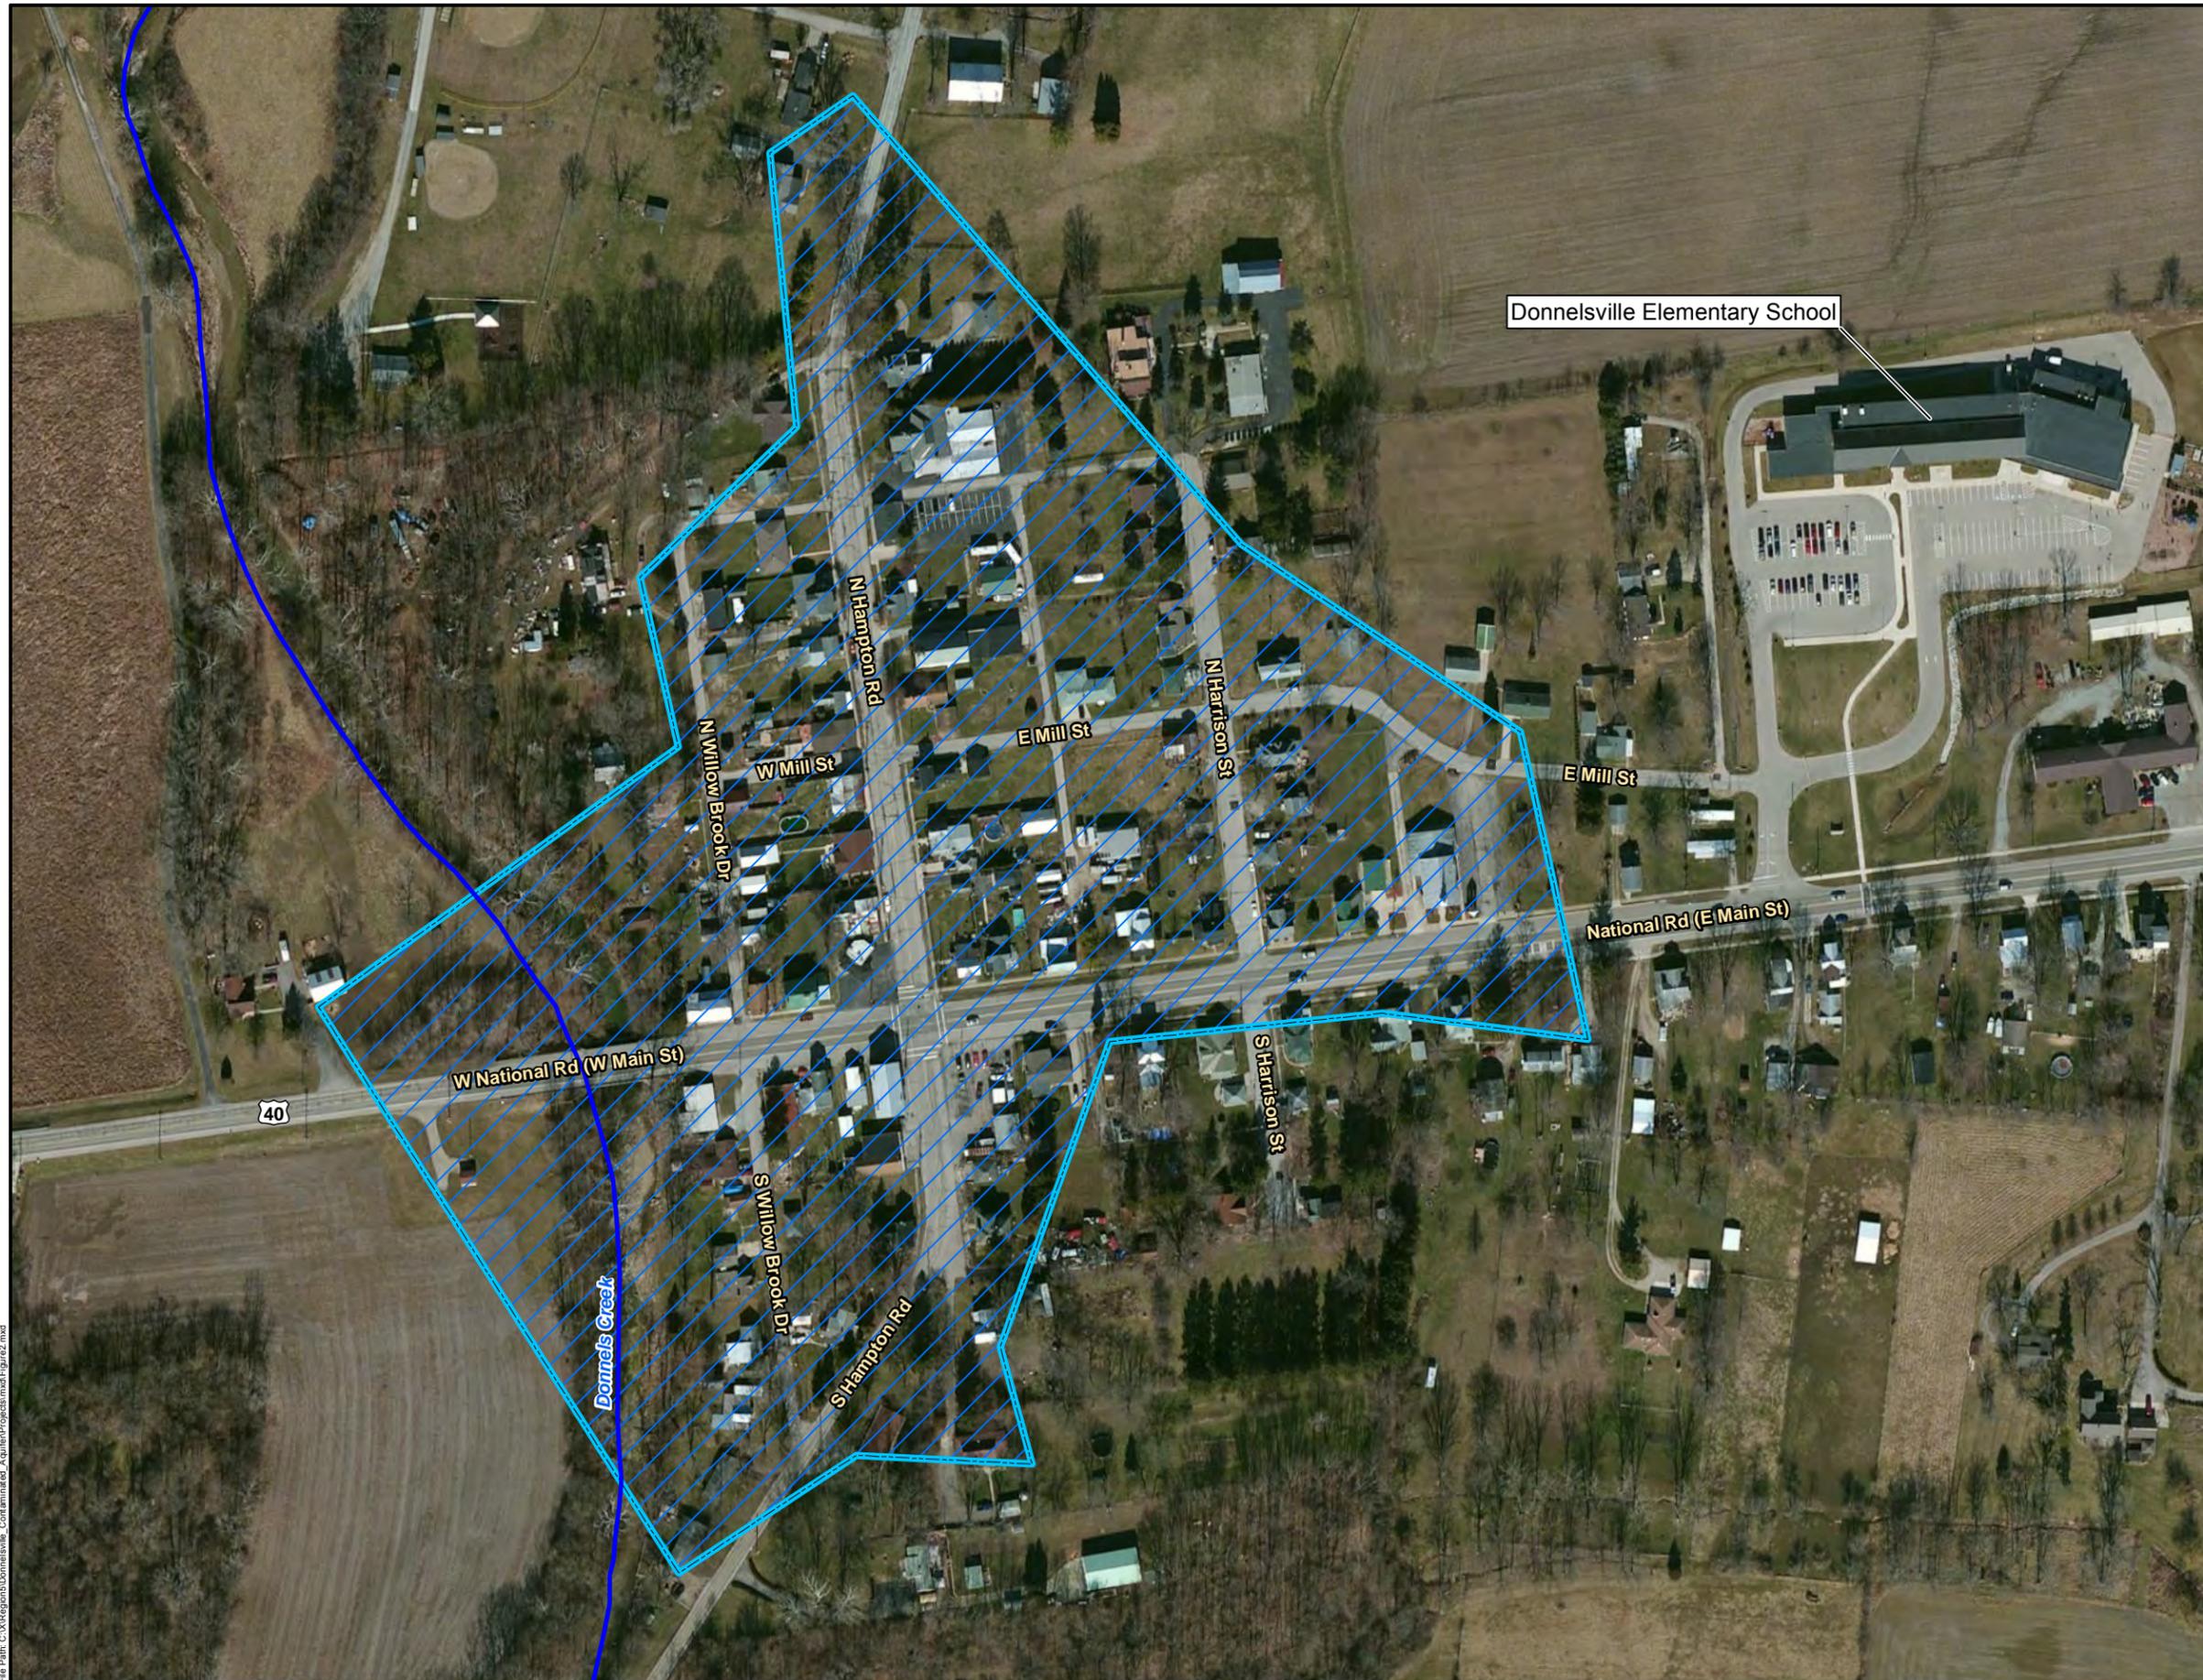
File Path: C:\X\Region5\Donnelsville_Contaminated_Aquifer\Project\mxd\Figure2.mxd

- Approximate Cumulative Historical Extent of Ground Water Plume
- Major Road

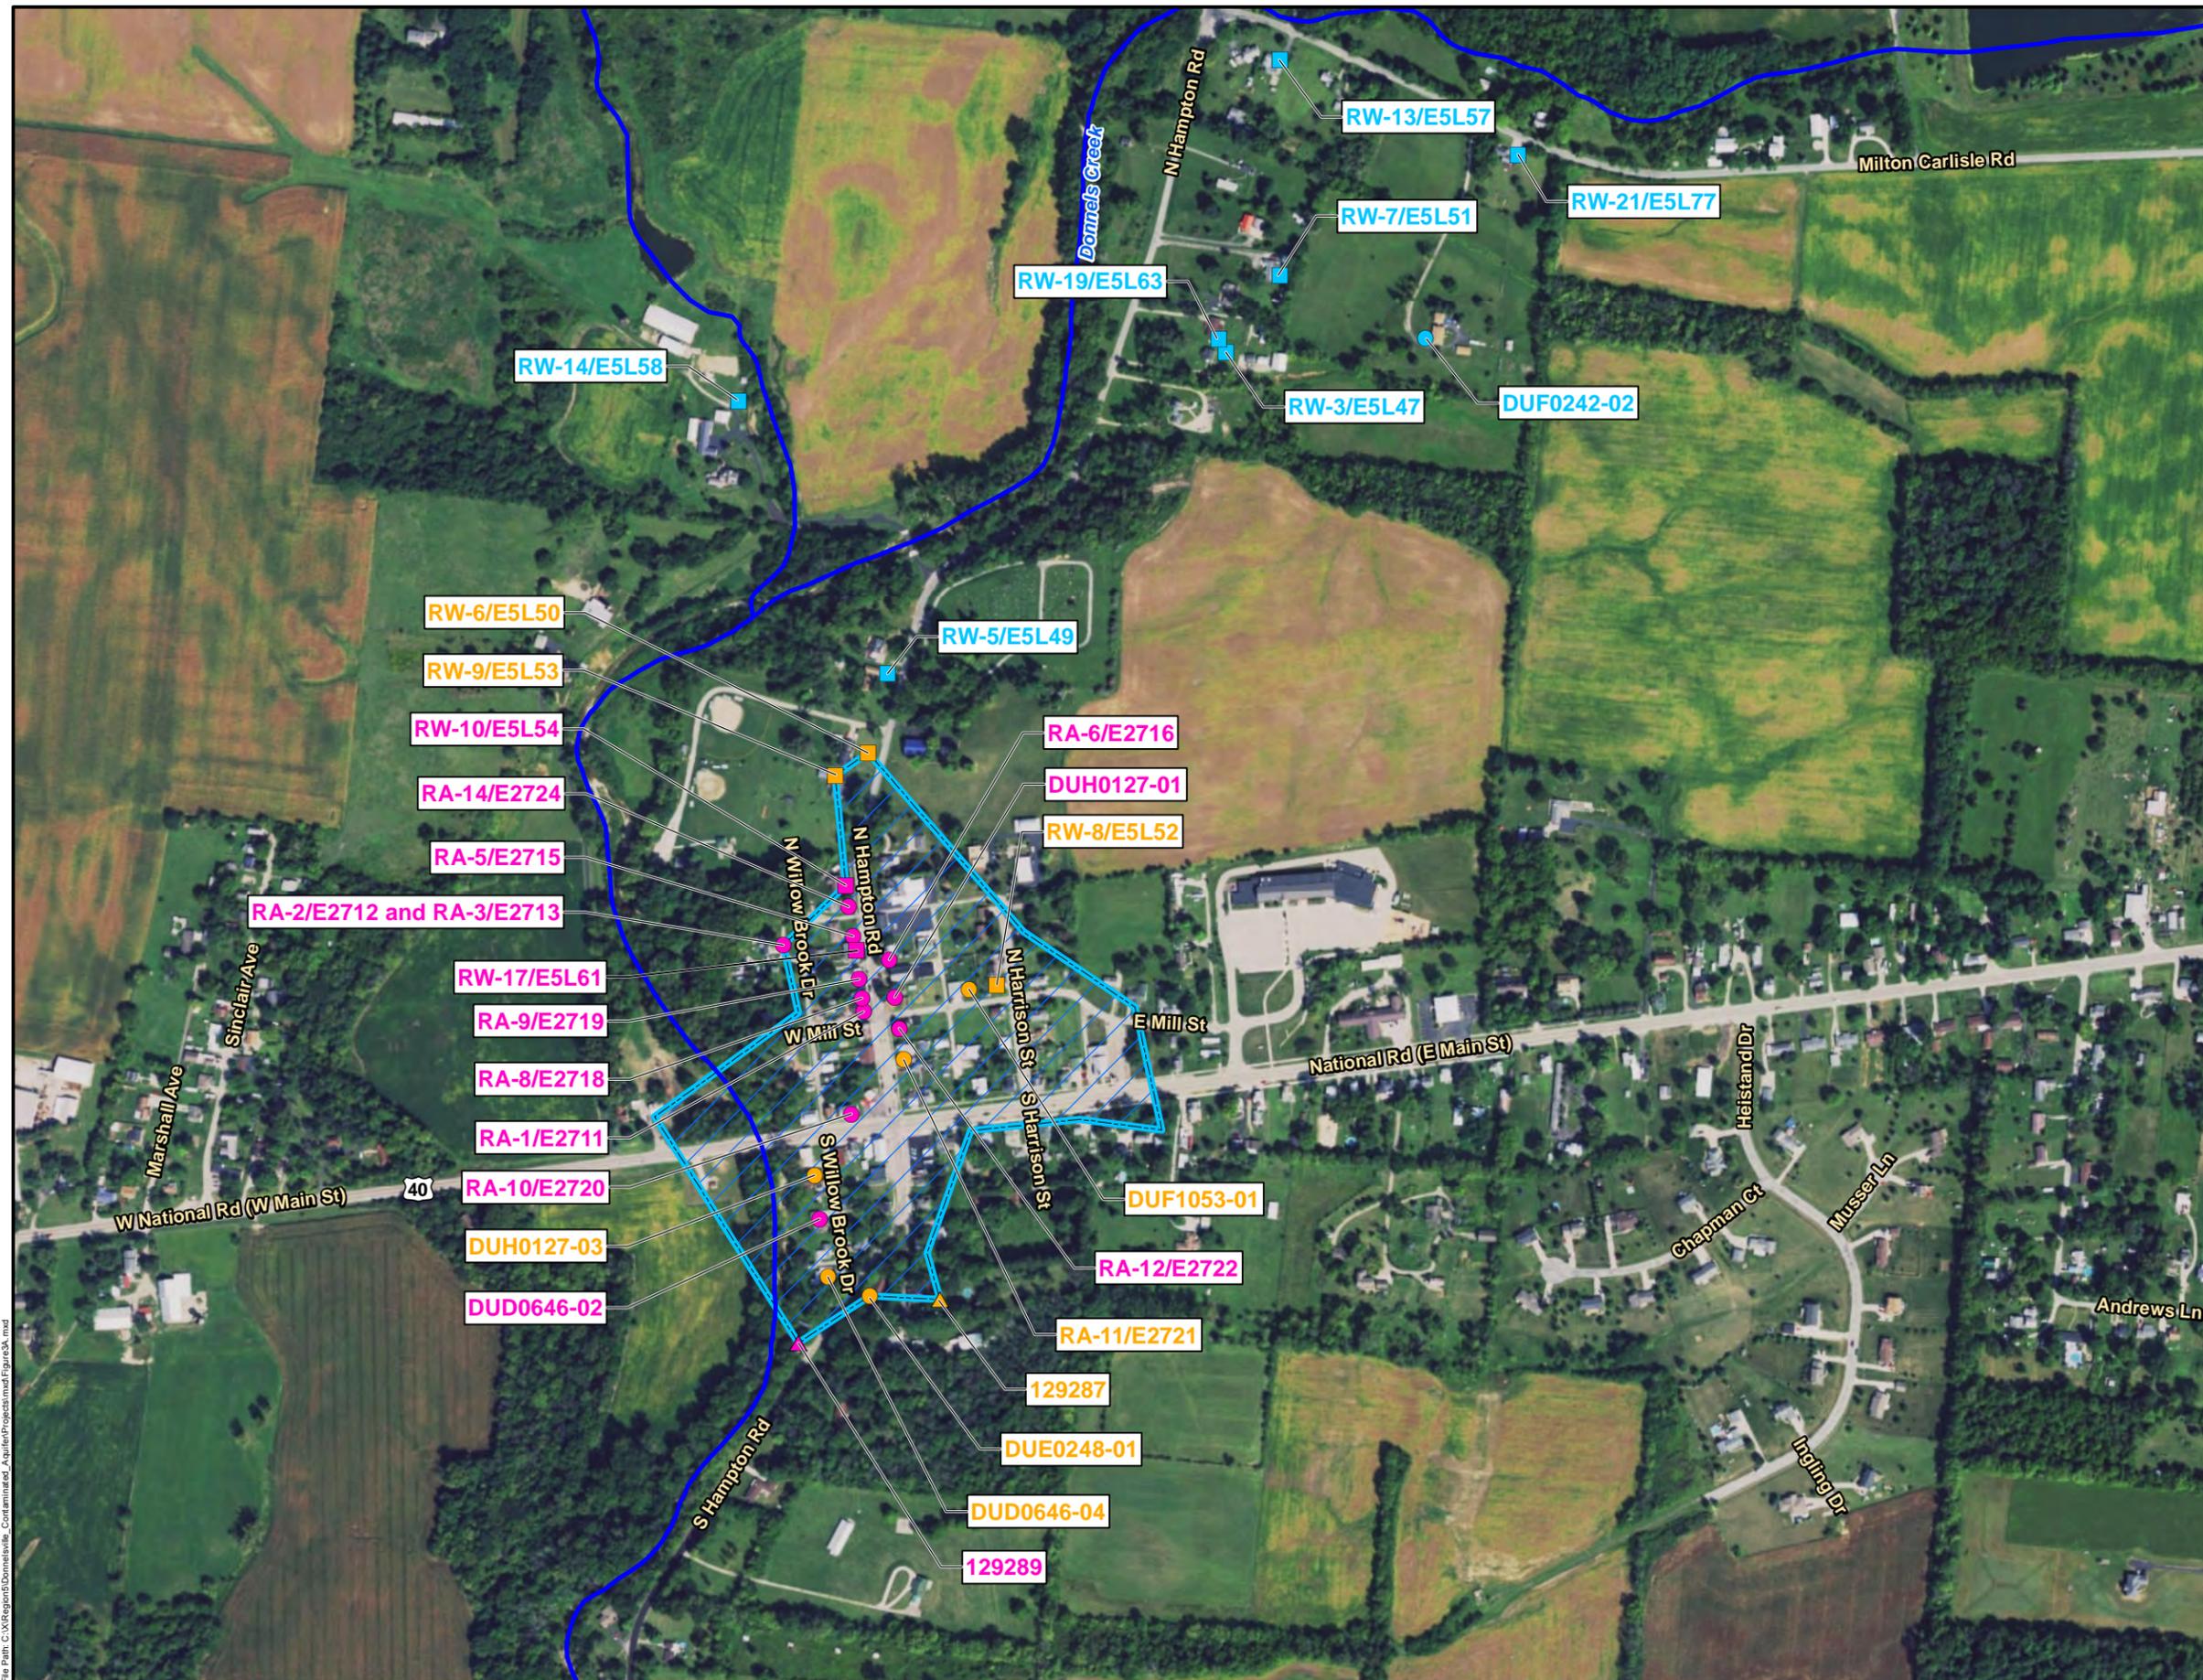
File Path: C:\X\Region5\Donnelsville_Contaminated_Aquifer\Project\mxd\Figure3A.mxd

Residential Drinking Water Well Samples

Table 1 lists sampling events at the DCA site since 2011, including hazardous substances detected in samples collected.

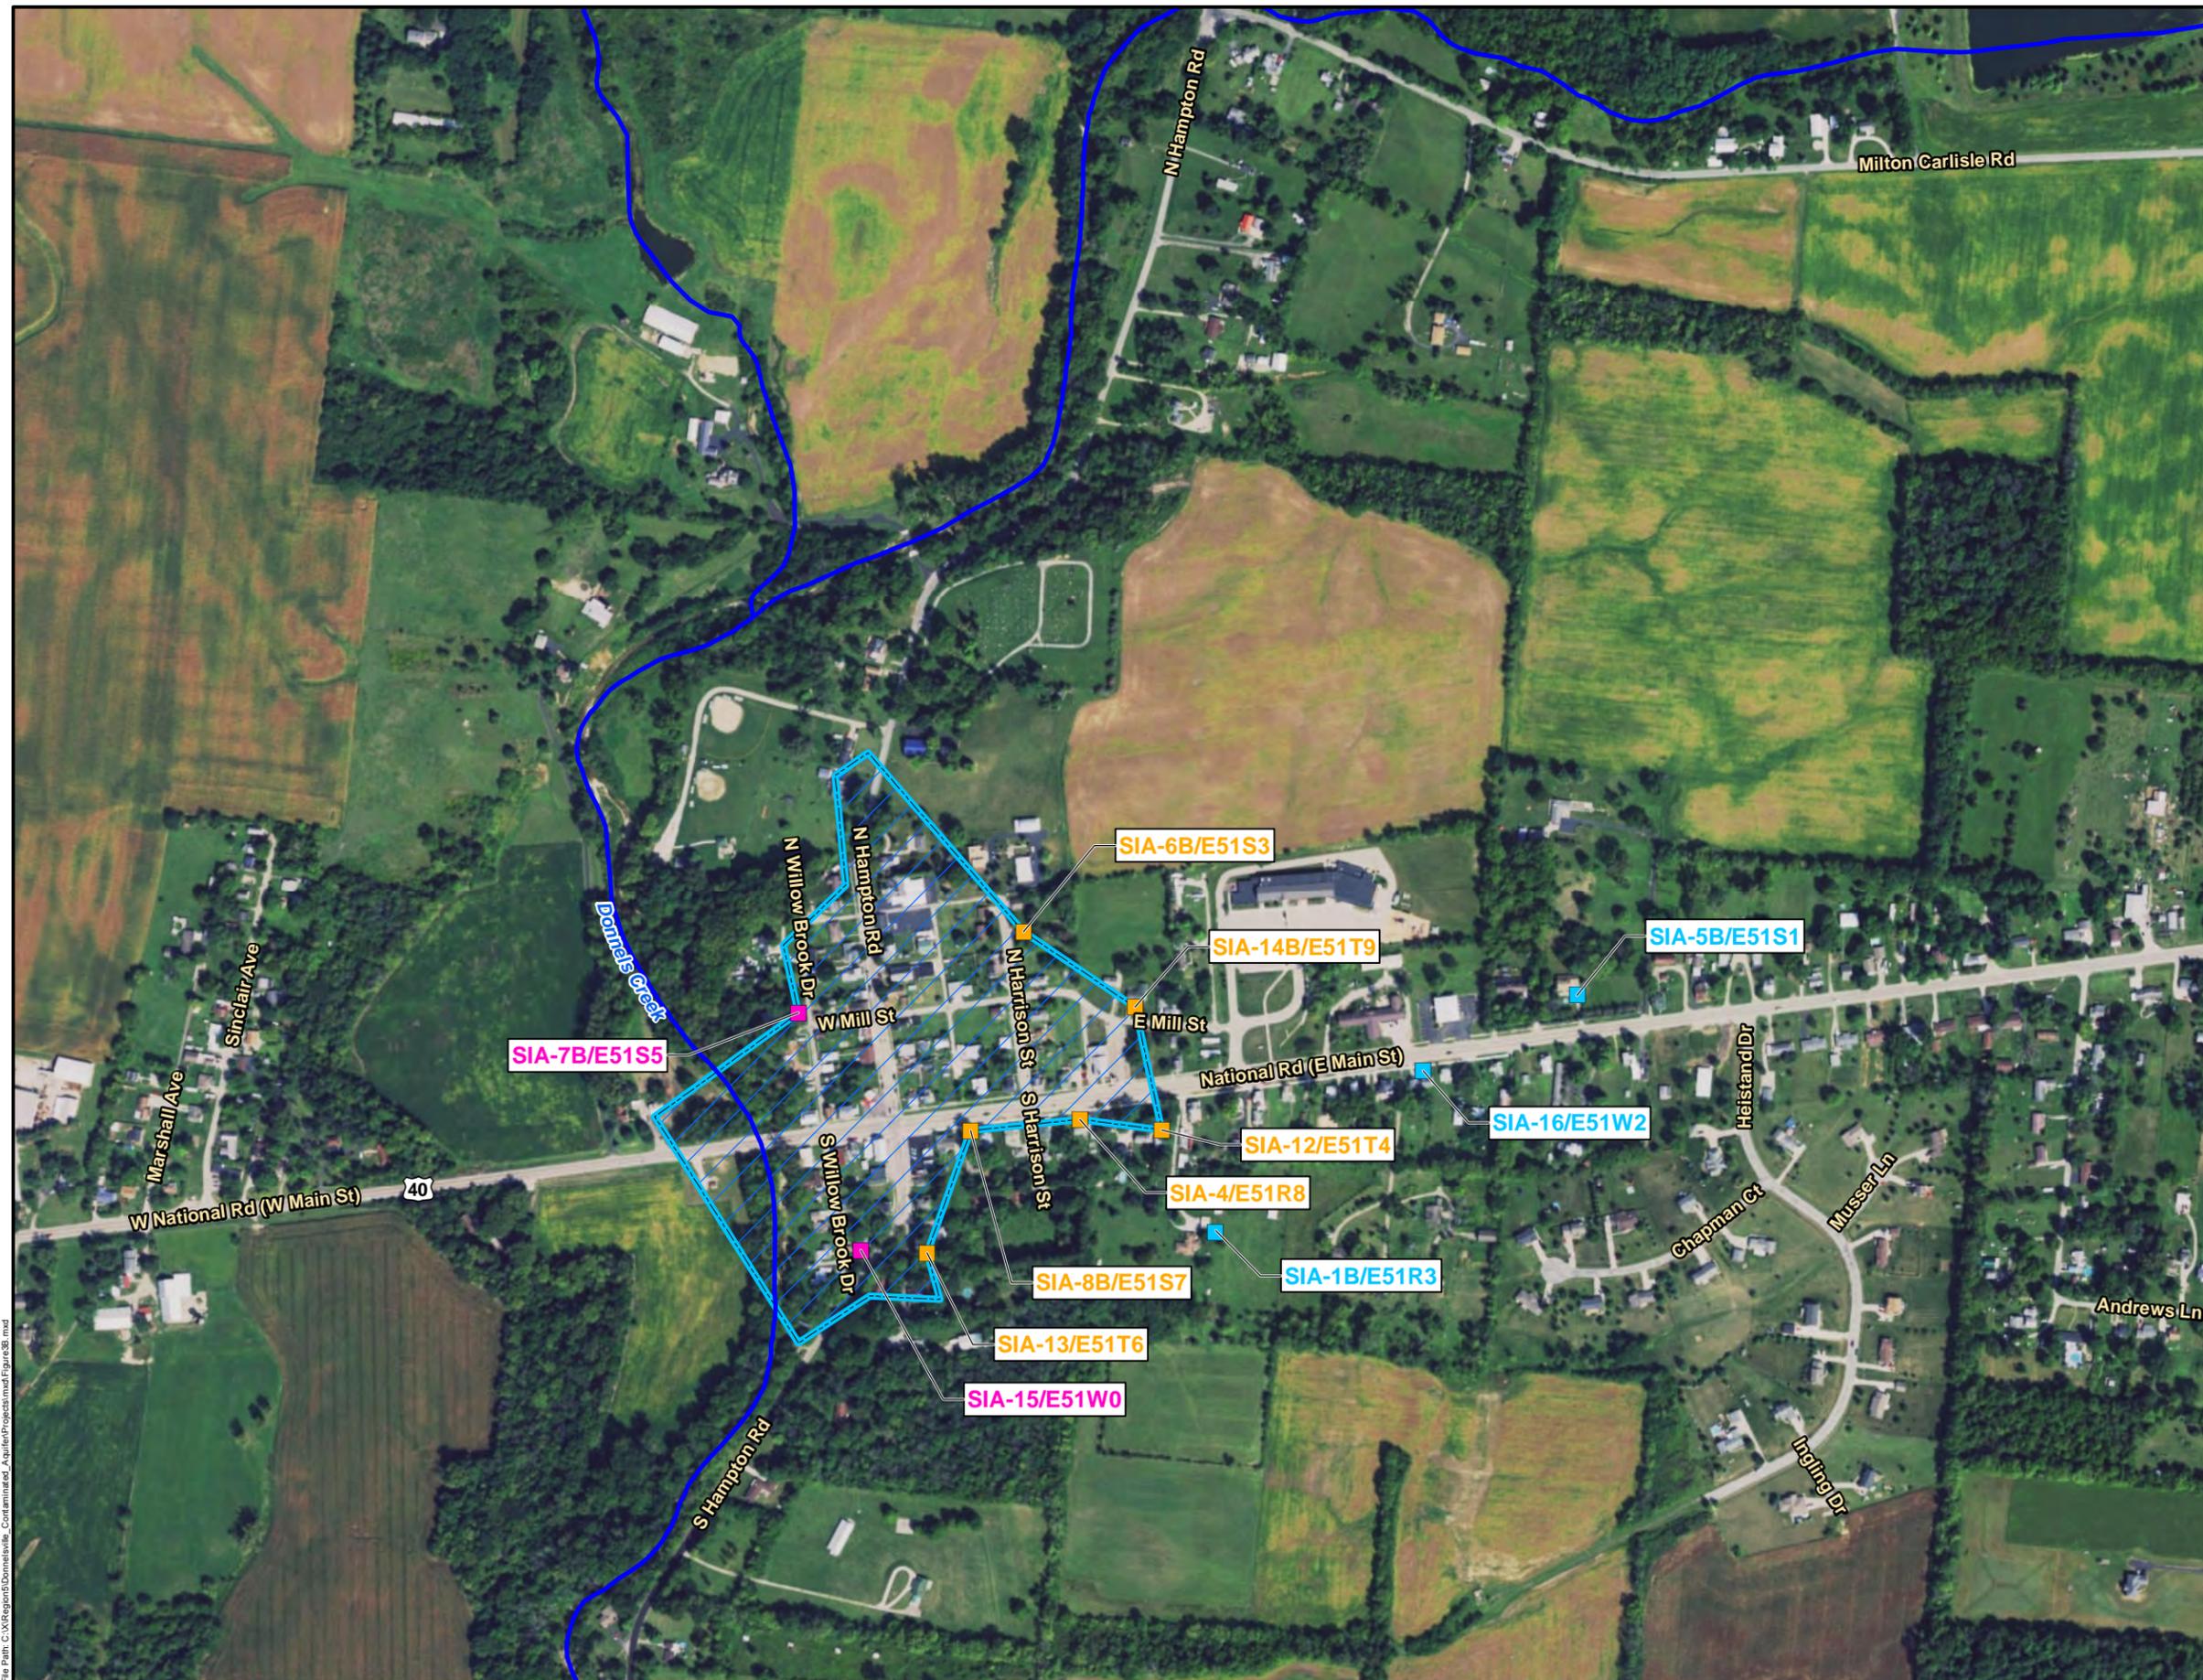
File Path: C:\X\Region5\Donnelsville_Contaminated_Aquifer\Project\Figures\Figure3B.mxd

Residential Drinking Water Well Samples

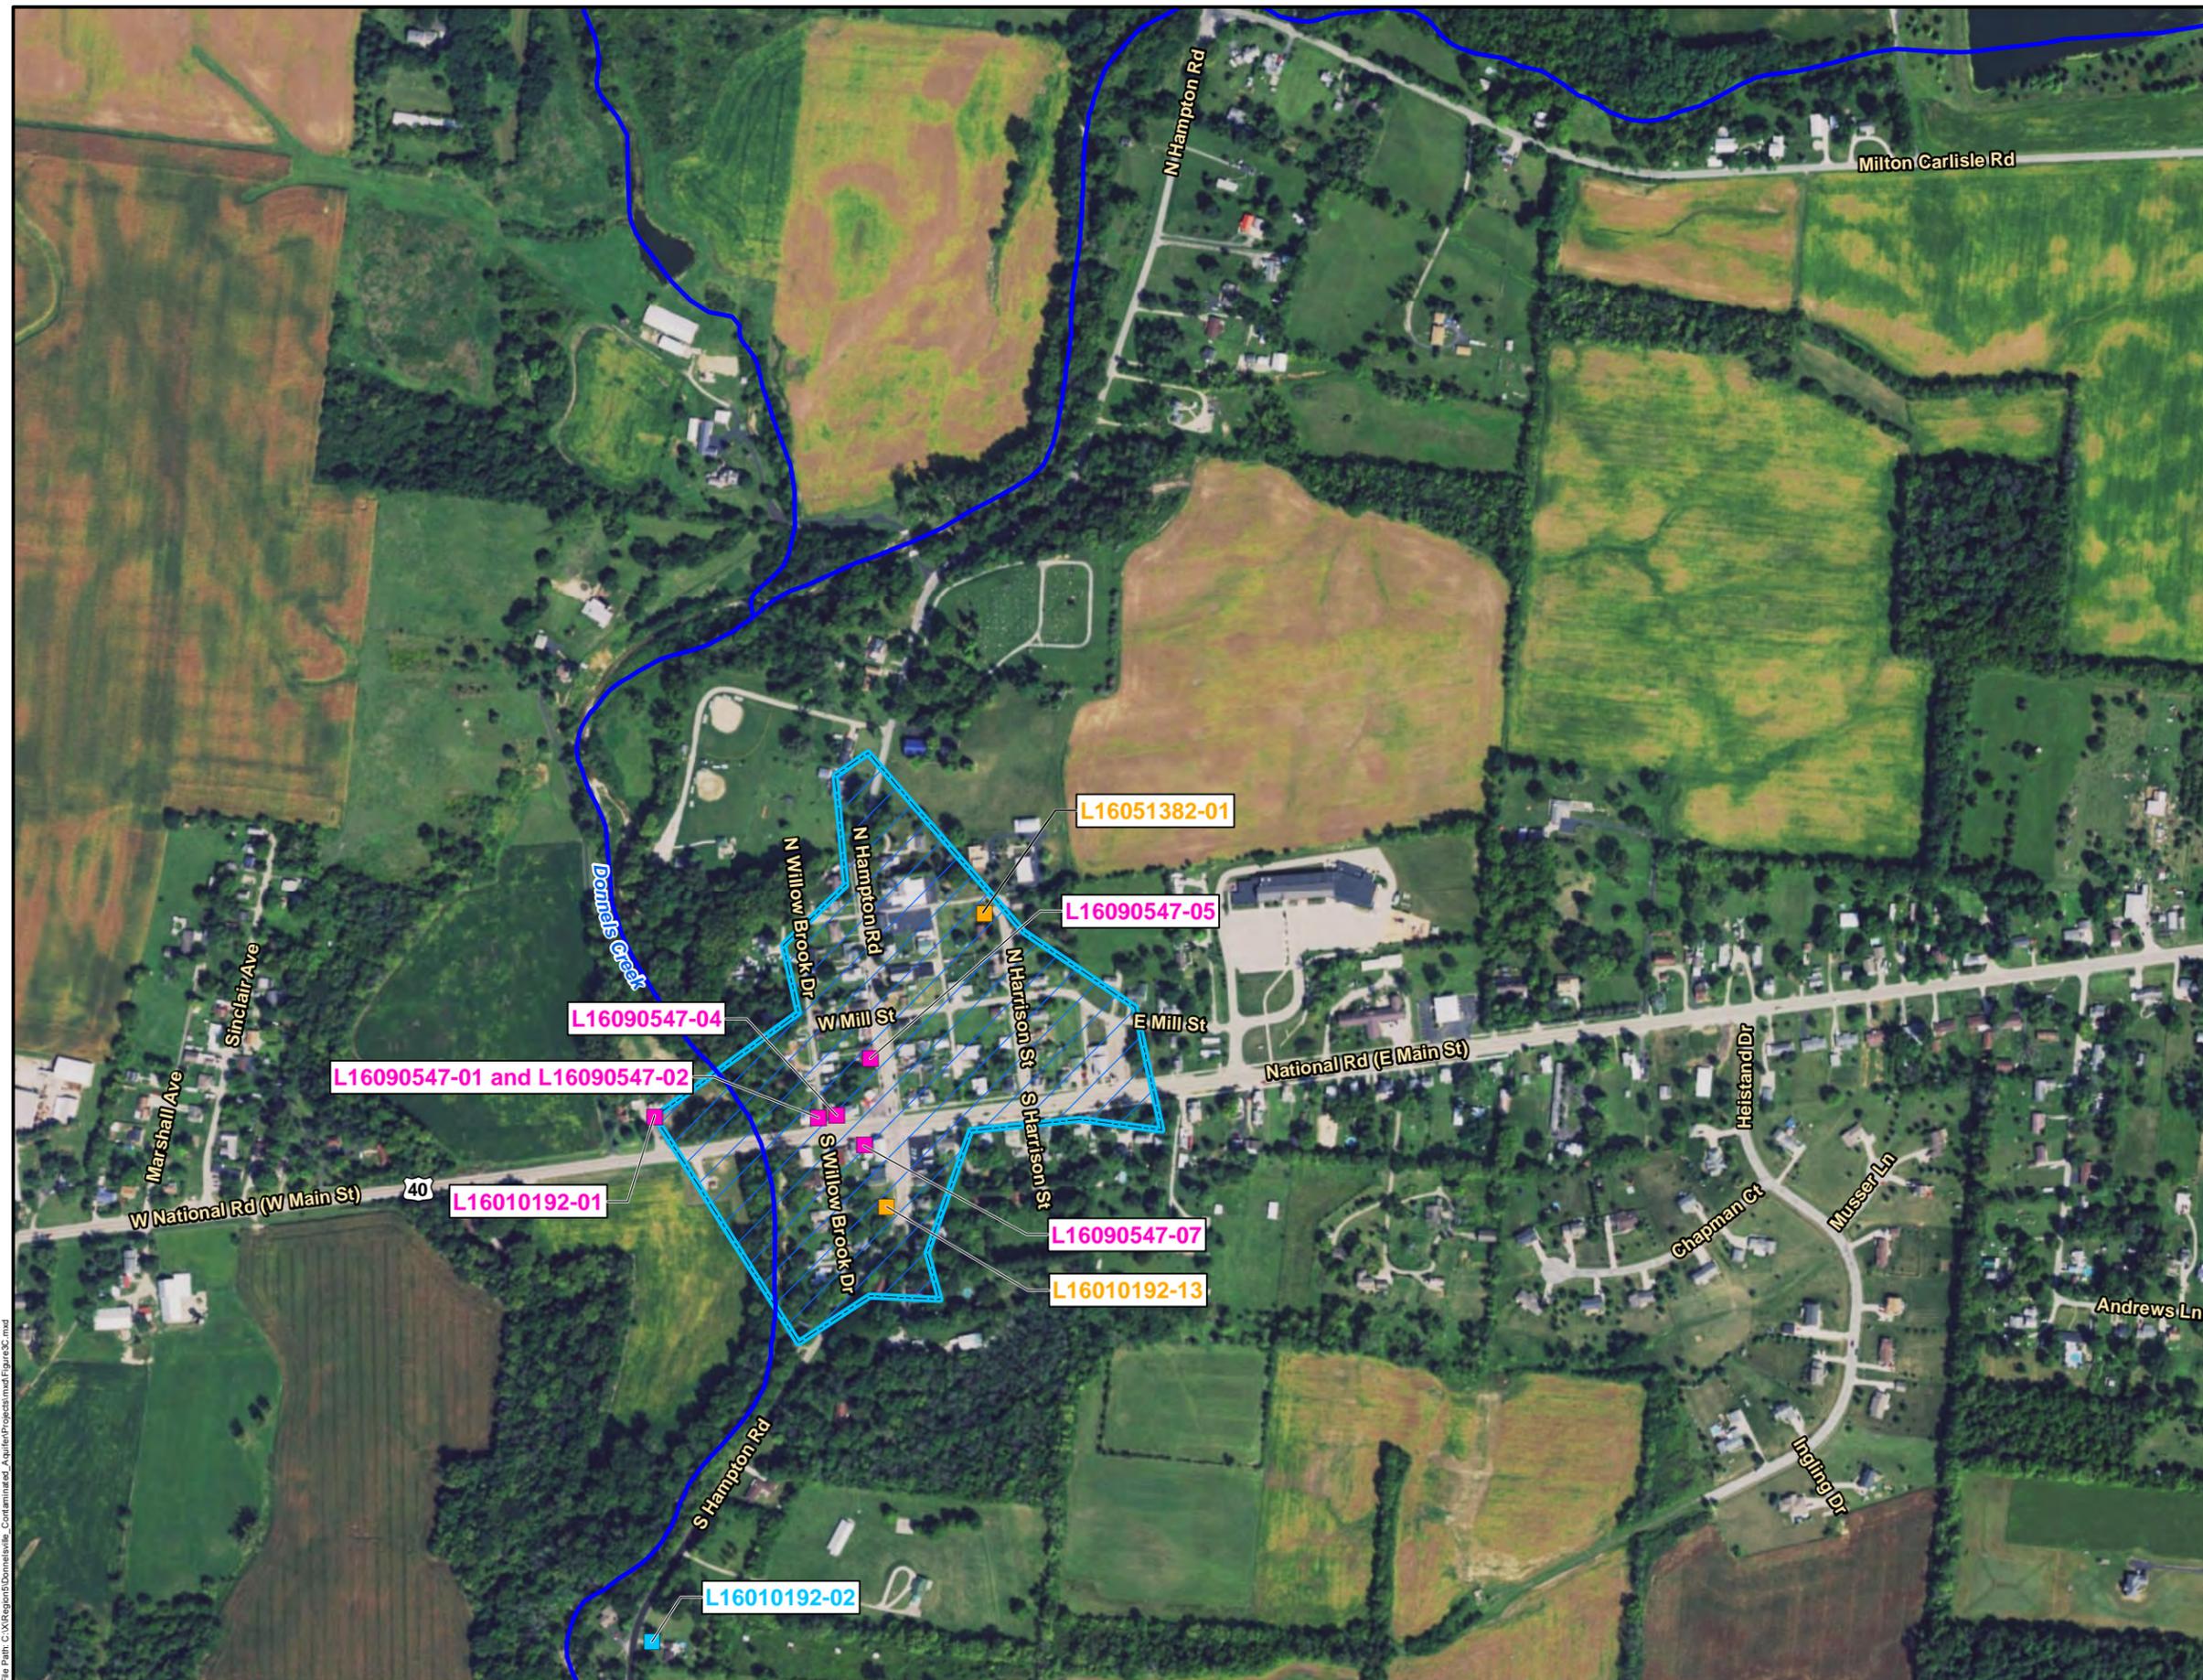
File Path: C:\X\Region5\Donnelsville_Contaminated_Aquifer\Project\mxd\Figure3C.mxd

Residential Drinking Water Well Samples

- Ohio EPA
- Creek
- Approximate Cumulative Historical Extent of Ground Water Plume

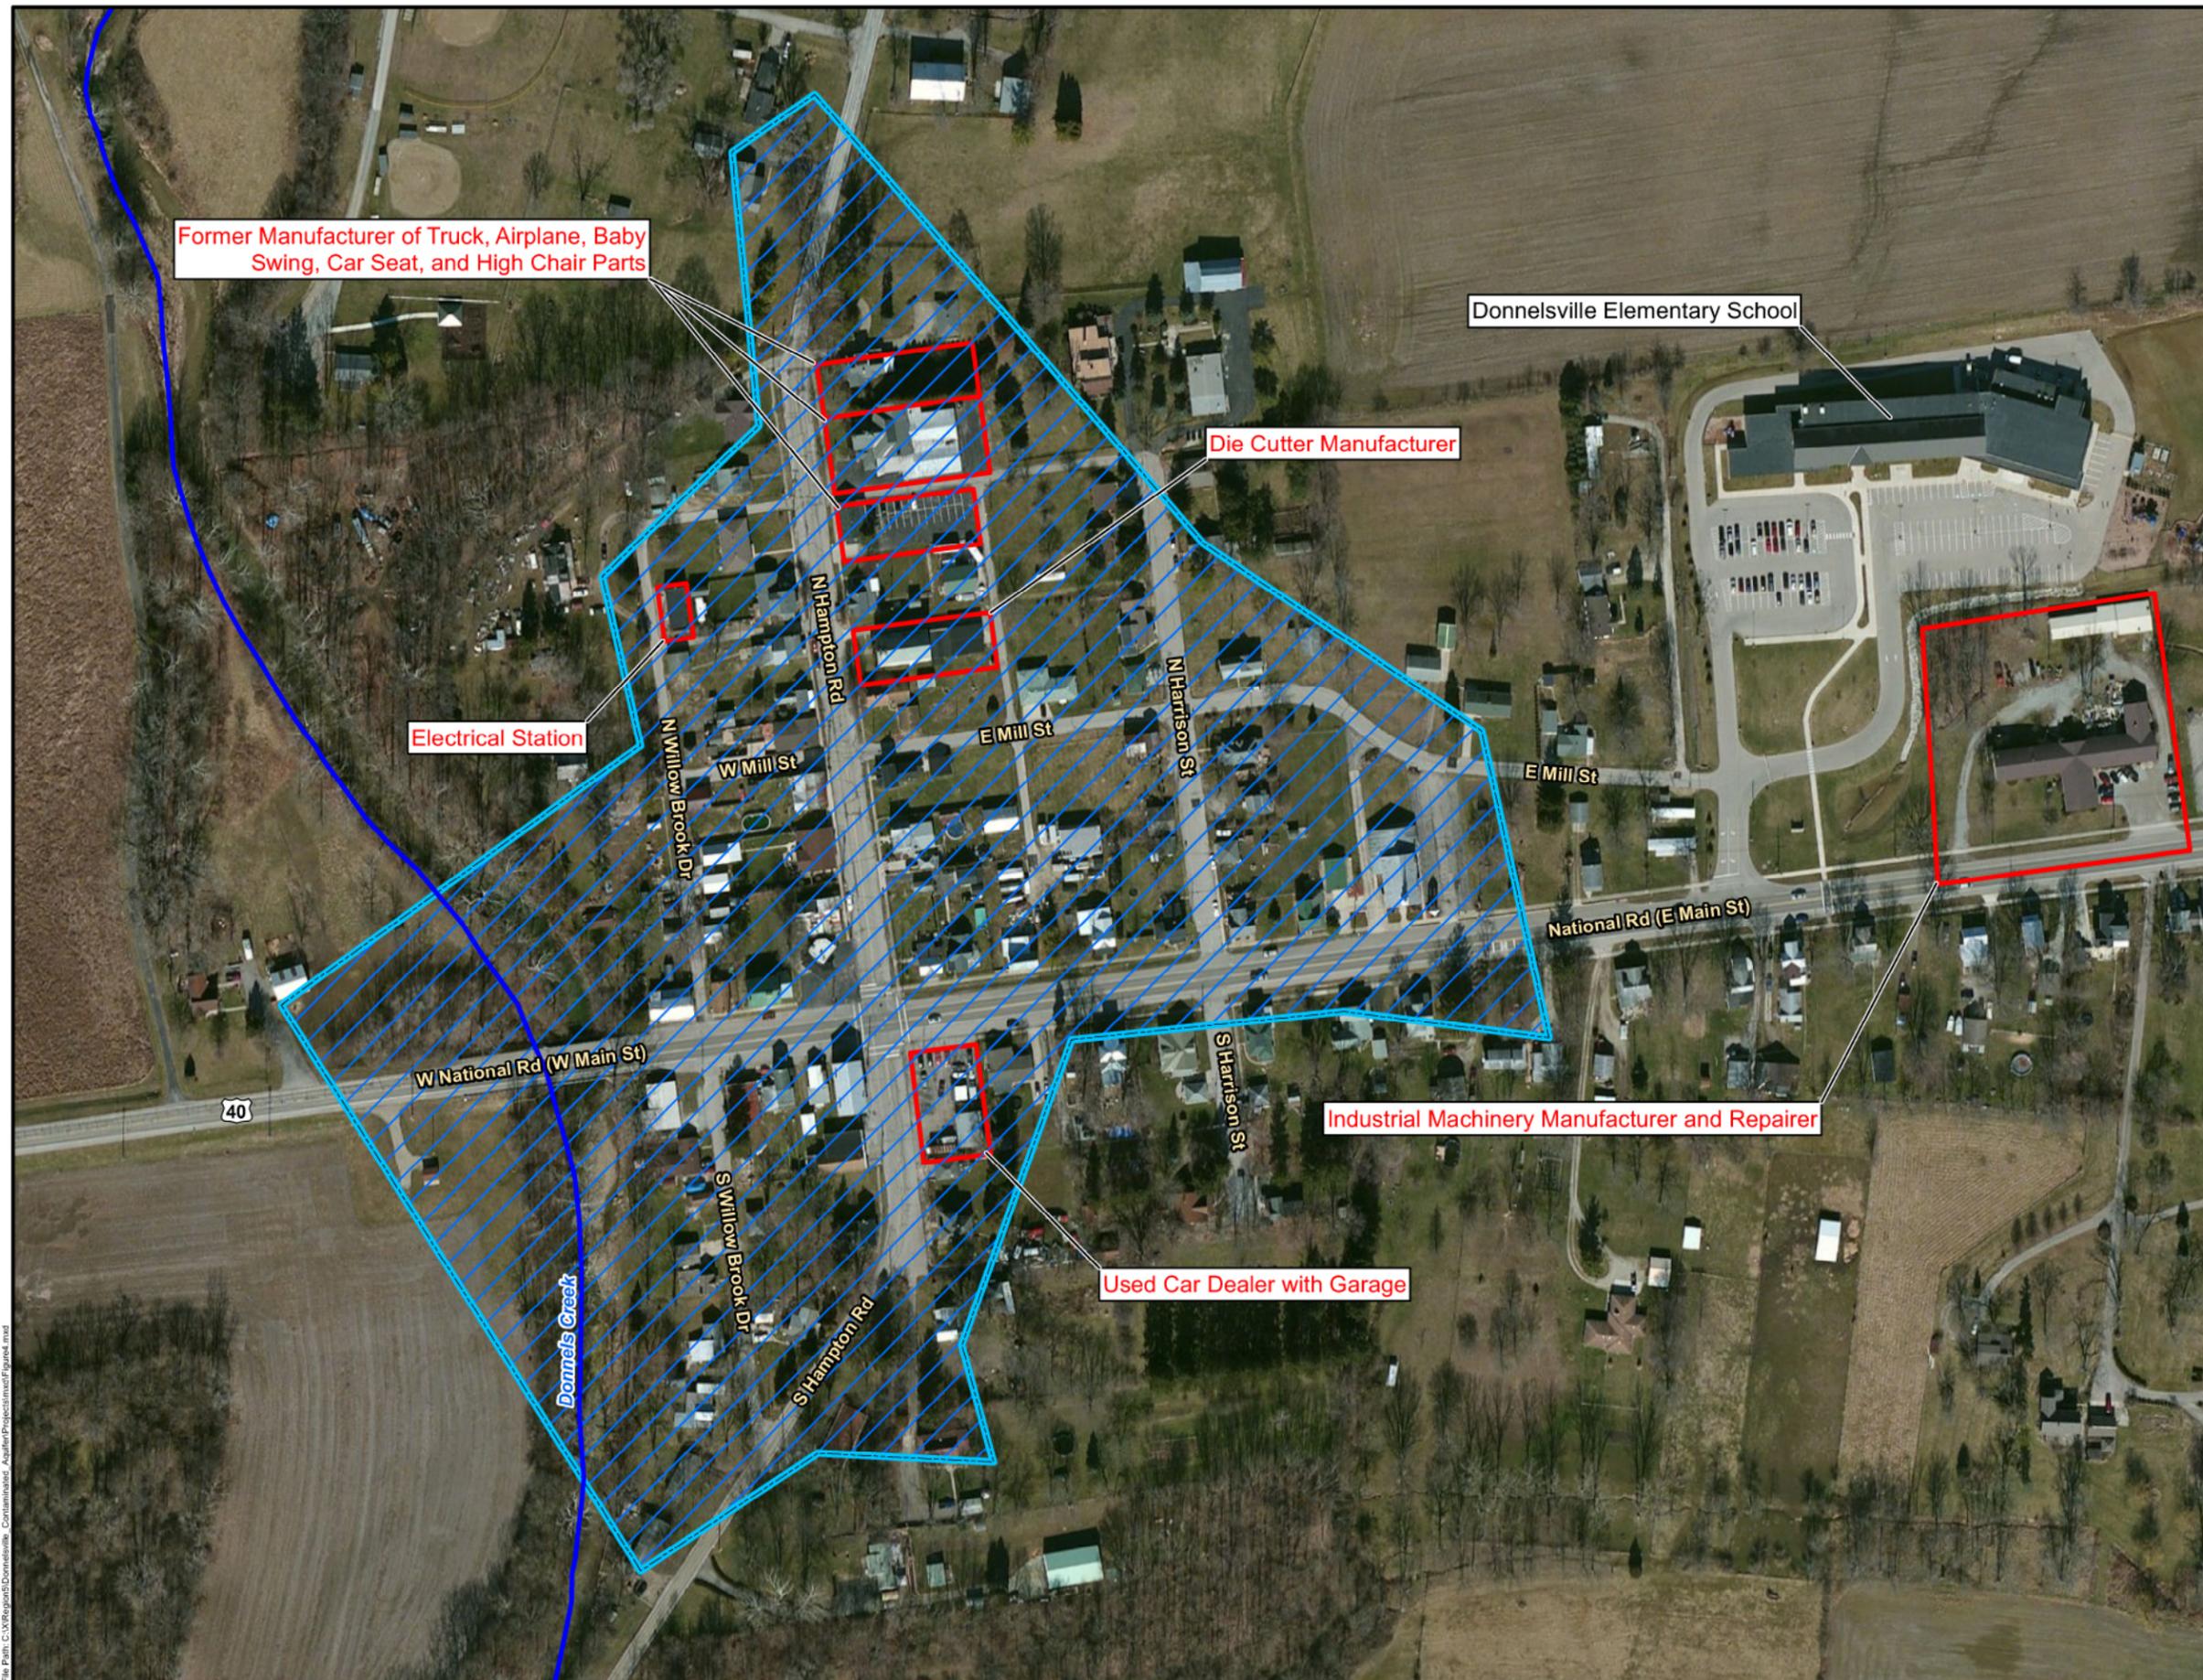
- Creek
- Approximate Cumulative Historical Extent of Ground Water Plume
- Possible Sources of Ground Water Contamination

During sampling events, Ohio EPA conducted an extensive level of effort by searching Ohio EPA and EPA records to identify possible sources of the groundwater contamination. See Reference 27 for more information on this search and a figure depicting the facilities identified. Facilities identified that are known to have used or may have used solvents similar to those found in the groundwater plume include an industrial machinery manufacturer and repairer, die cutter manufacturer, used car dealer that included a garage used for repairs, electrical station, and a former manufacturer of truck, airplane, baby swing, car seat, and high chair parts. Tool and die operations as well as a vapor degreaser were located at this former manufacturing location (Ref. 27, pp. 1, 2, 3, 4, 5) (see Figure 4 of this HRS documentation record).
